USA-CERL TECHNICAL REPORT M-88/08
April 1988

Evaluation of Protective Coatings for Aluminum Torpedoes: Phase II

This report documents the second phase of research conducted to select, test, and evaluate protective coating systems for the Navy's MK 48 Torpedoes. Phase I of the research evaluated nine coating systems at different thicknesses and applied on different pretreated substrates. These results are documented in USA-CERL Technical Report M-329.

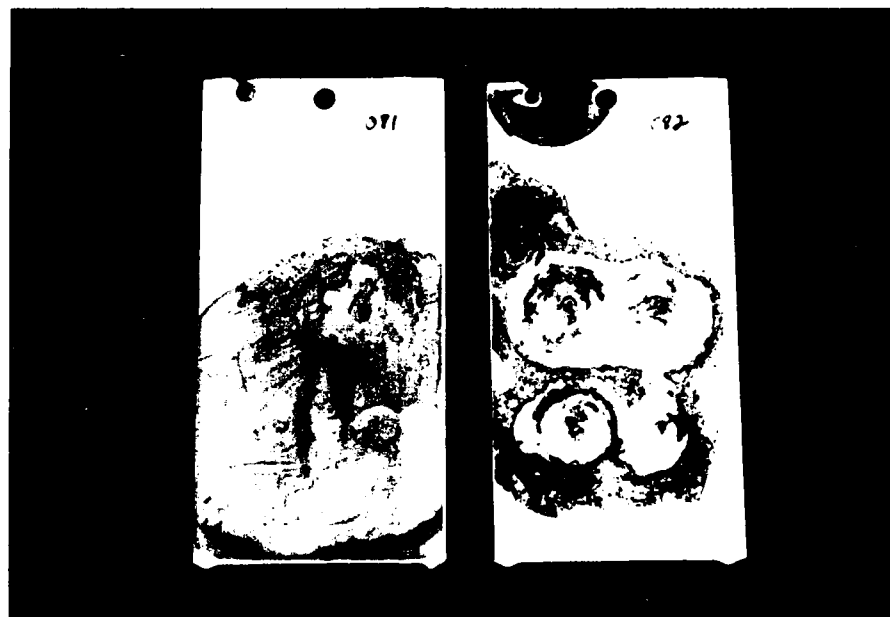
Figure 23. System 5 impacted, coupled.

4. System 5 (P/C-126). This system had excellent corrosion resistance on both damaged and undamaged uncoupled panels, as well as on the undamaged coupled panels. Impacted coupled panels corroded at the 10-, 20-, and 40-in.-lb impact points, and corrosion undercut the film on 50 percent of the surface area of these panels (Figure 23). These panels were rated poor. Scored coupled specimens pitted deeply along the score lines and were rated fair.
